GERIATRIC AND LONG-TERM CARE DEATH REVIEW COMMITTEE

OCC file: 2021-2029 (GLTCRC 2023-16)

Reason for Review:

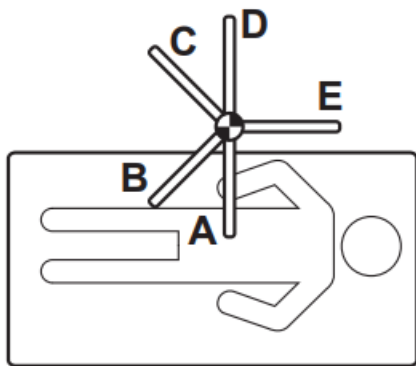
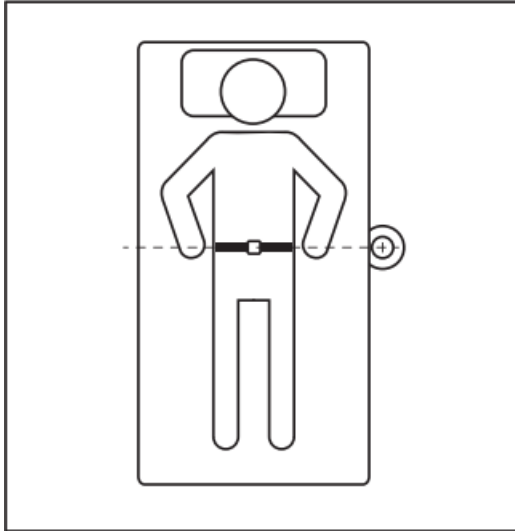
Bedroom installation:

SUPERPOLE PLACEMENT FIGURE E. 1. BEDROOM - Locate pole adjacent to waistline, and as close to bed as possible while allowing clearance for bed coverings. 2. BATHTUB ONLY - Locate pole base against tub, approximately half way along its length 3. SEATING (TOILET or CHAIR) - To provide clearance when standing, locate pole 3-10" / 76mm-254mm forward of the knees, and 2-6" / 51mm-154mm to the side of knees when sitting.

Despite the risk of entrapment with the pole close to the bed, the installation instructions do not provide a specific distance that the pole should be placed from the bed. This distance is only specified on the company website. The distance provided in the installation instructions is: “allowing clearance for bed coverings”. The more detailed entrapment instructions on the manufacturer’s website indicate: “a pole gap of less than 2.375" / 60mm, or greater than 12" / 305mm.” In 2013, the GLTCRC reviewed a similar case of positional asphyxia from a transfer pole where the decedent was trapped at chest level. The distance of 12 inches may not be sufficient to prevent entrapment at chest level for larger persons. There is no specific reference to entrapment by transfer poles on the Health Canada website.

3. Manufacturers of transfer pole devices should provide specific measurements for installation in the instruction guide that accompanies the pole. The committee suggests that the pole be placed at a distance further than the width of the person using it and not close to the bed. Beds or furniture should be fixed or against a wall to prevent movement which might create an entrapment gap.

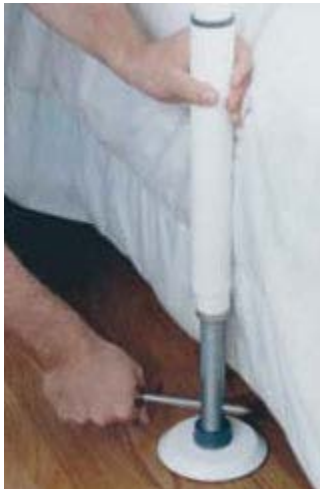
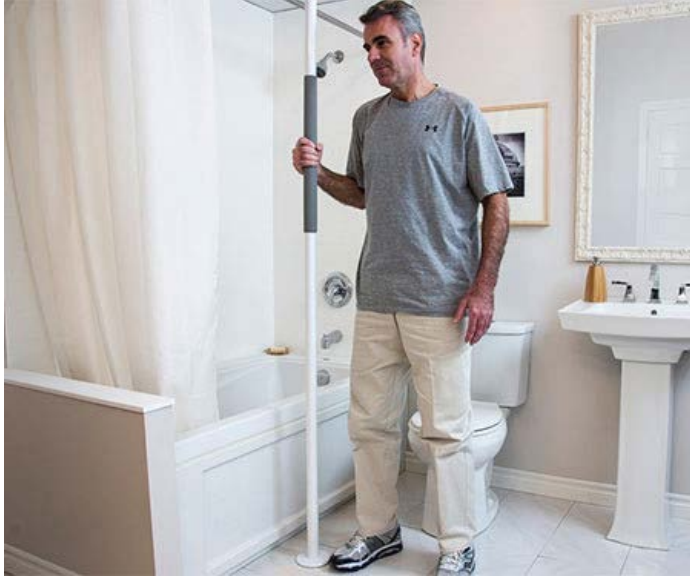
Photos from plumbing supply website on installation.

The manufacturers installation instructions do provide warning for potential bed entrapment:

“WARNING - PATIENT ENTRAPMENT (see additional guidelines) The potential risk of entrapment (limb, neck, head, torso) between the pole and adjacent item (i.e. bed, toilet, etc.) can be reduced or avoided by the following strategies: 1. Situate the pole at a distance that is considerably smaller or larger than that which could result in entrapment. 2. Consider situations that could change with time or usage such as mattress compression, patient movement, bed position changes due to electrically powered beds, etc. 3. Realize that this product is not intended as a physical constraint or barrier to exiting the bed.”

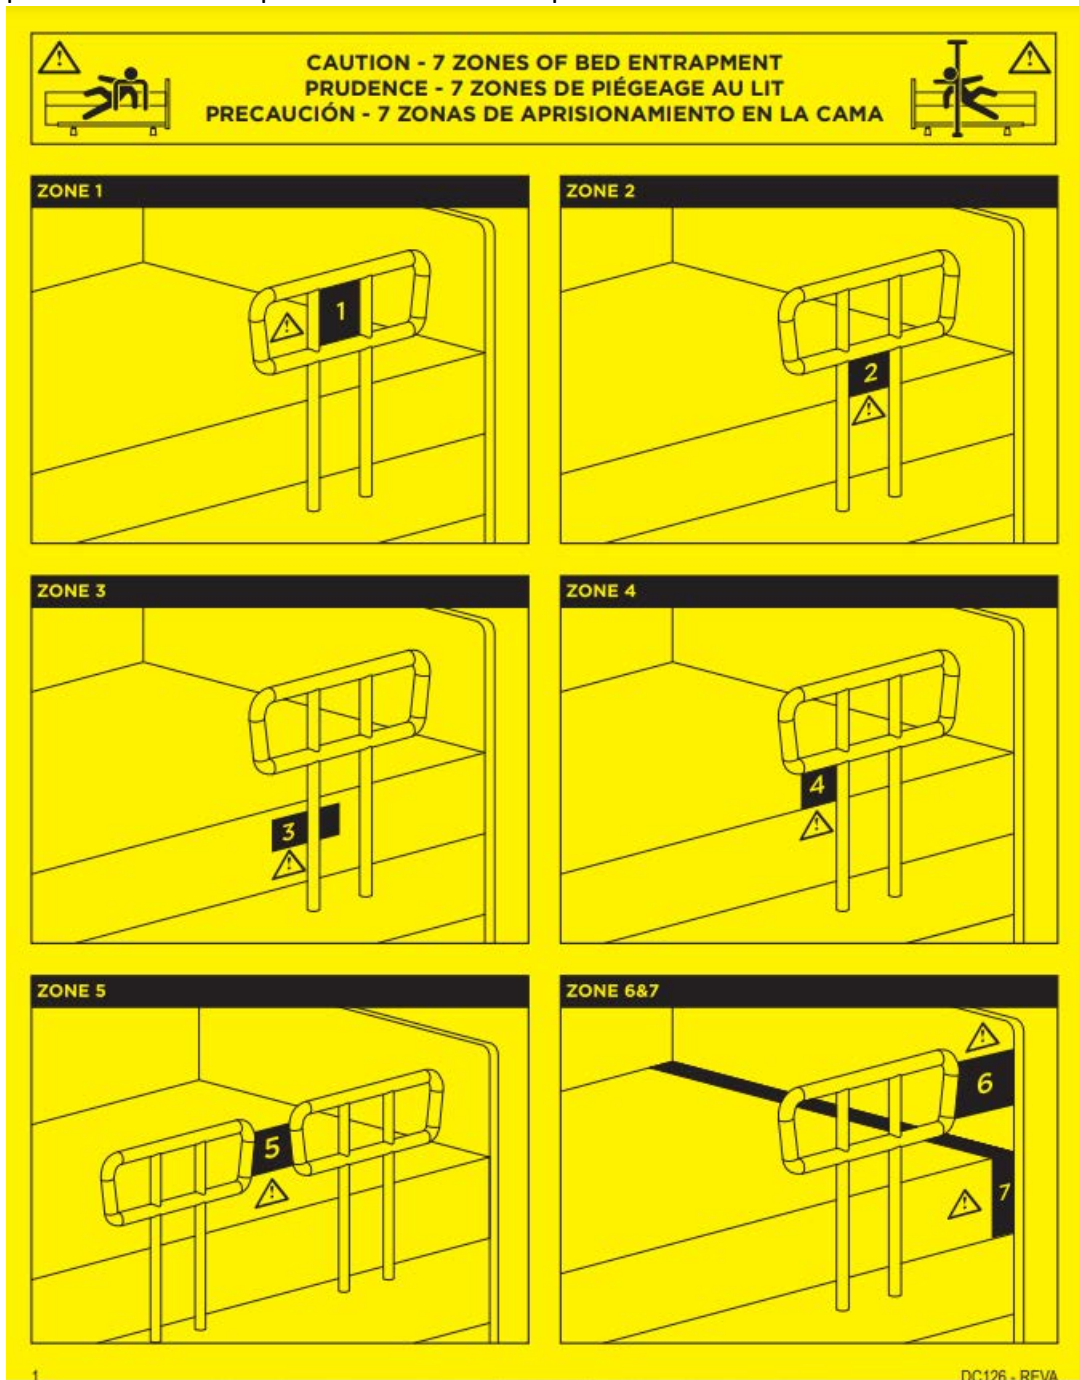
“ZONE 3 - BETWEEN THE RAIL AND THE MATTRESS This area is the space between the inside surface of the bed rail and the mattress. If too large of a space it can cause a risk of head entrapment. FDA recommended space: less than 4.75" / 120mm. All HealthCraft bed rails include a safety strap that holds the bed rail tight against the side of the mattress. The safety strap must always be used to reduce the risk of injury or death. **Note that this gap may also be created by a fixed structure alongside a bed such as an I.V. pole or a floor to ceiling support pole. If a support pole is being used beside the bed, we recommend a pole gap of less than 2.375" / 60mm, or greater than 12" / 305mm.** (From Hospital Bed Safety Workgroup (HBSW) and the U.S. Food and Drug Administration (FDA))

Health Canada Bed Entrapment Guidelines recommend a less than 4 3/4" gap between the mattress and bed rail. This represents head width. Unable to find prescribed distance for prevention of entrapment with a transfer pole.
