## GERIATRIC AND LONG-TERM CARE DEATH REVIEW COMMITTEE

**OCC file:** 2021-2029 (GLTCRC 2023-16)

### **Reason for Review:**

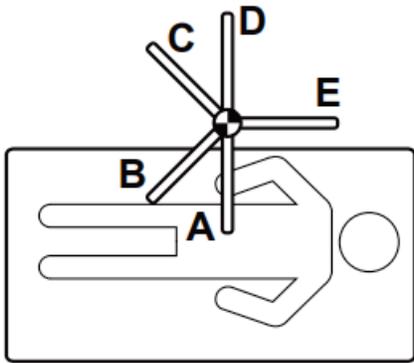
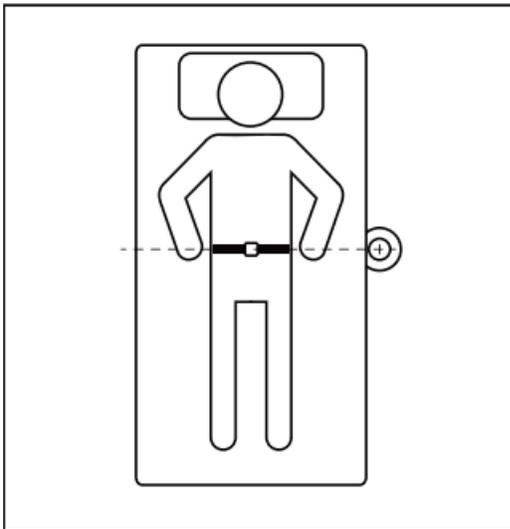
Bedroom installation:

**SUPERPOLE PLACEMENT FIGURE E. 1. BEDROOM - Locate pole adjacent to waistline, and as close to bed as possible while allowing clearance for bed coverings.**  
**2. BATHTUB ONLY - Locate pole base against tub, approximately half way along its length**  
**3. SEATING (TOILET or CHAIR) - To provide clearance when standing, locate pole 3-10" / 76mm-254mm forward of the knees, and 2-6" / 51mm-154mm to the side of knees when sitting.**

Despite the risk of entrapment with the pole close to the bed, the installation instructions do not provide a specific distance that the pole should be placed from the bed. This distance is only specified on the company website. The distance provided in the installation instructions is: “allowing clearance for bed coverings”. The more detailed entrapment instructions on the manufacturer’s website indicate: “a pole gap of less than 2.375” / 60mm, or greater than 12” / 305mm.” In 2013, the GLTCRC reviewed a similar case of positional asphyxia from a transfer pole where the decedent was trapped at chest level. The distance of 12 inches may not be sufficient to prevent entrapment at chest level for larger persons. There is no specific reference to entrapment by transfer poles on the Health Canada website.

3. Manufacturers of transfer pole devices should provide specific measurements for installation in the instruction guide that accompanies the pole. The committee suggests that the pole be placed at a distance further than the width of the person using it and not close to the bed. Beds or furniture should be fixed or against a wall to prevent movement which might create an entrapment gap.

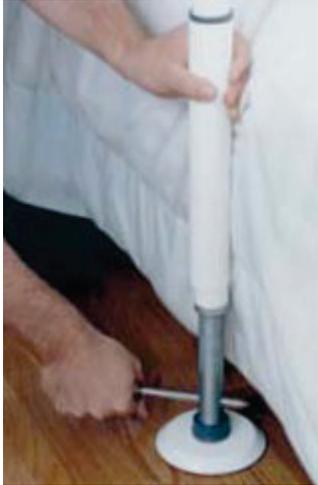
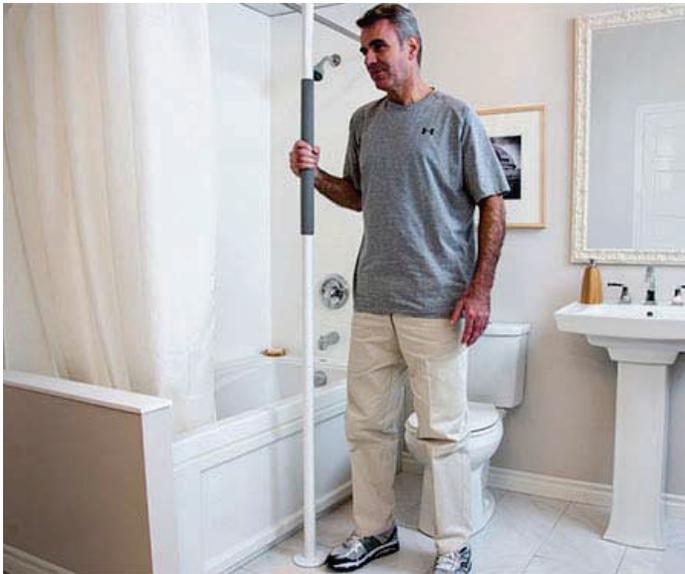
Photos from plumbing supply website on installation.

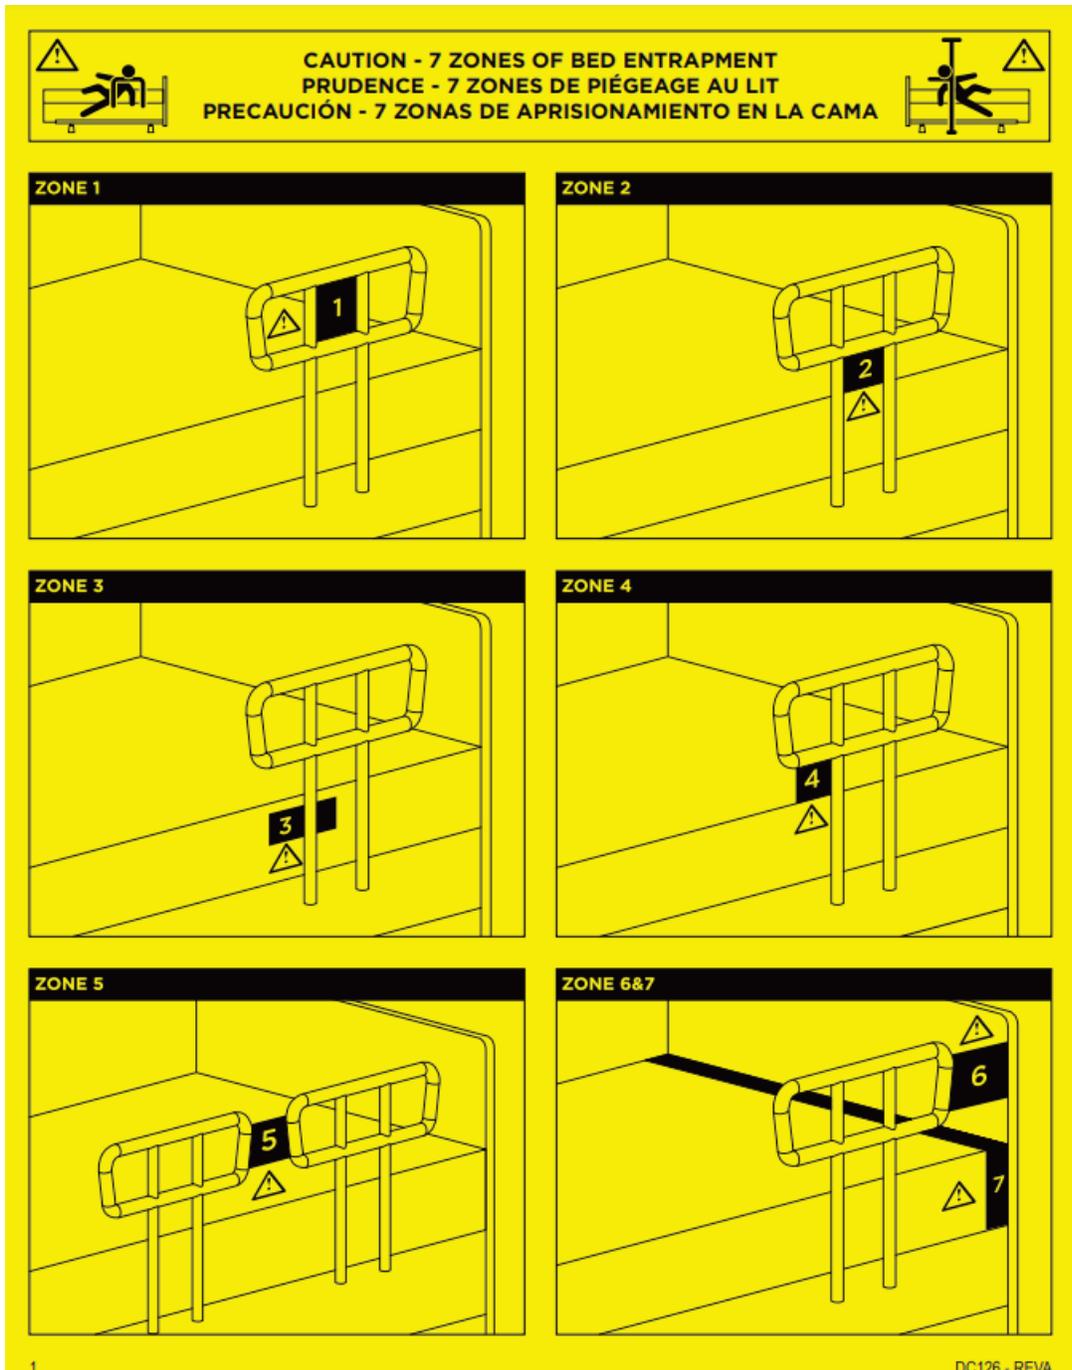
<https://healthcraftproducts.com/wp-content/uploads/2023/03/DC126-Bed-Entrapment-Prevention.pdf>

“ZONE 3 - BETWEEN THE RAIL AND THE MATTRESS This area is the space between the inside surface of the bed rail and the mattress. If too large of a space it can cause a risk of head entrapment. FDA recommended space: less than 4.75" / 120mm. All HealthCraft bed rails include a safety strap that holds the bed rail tight against the side of the mattress. The safety strap must always be used to reduce the risk of injury or death. **Note that this gap may also be created by a fixed structure alongside a bed such as an I.V. pole or a floor to ceiling support pole. If a support pole is being used beside the bed, we recommend a pole gap of less than 2.375" / 60mm, or greater than 12" / 305mm.** (From Hospital Bed Safety Workgroup (HBSW) and the U.S.Food and Drug Administration (FDA))

Health Canada Bed Entrapment Guidelines recommend a less than 4 3/4" gap between the mattress and bed rail. This represents head width. Unable to find prescribed distance for prevention of entrapment with a transfer pole.

2. The committee feels there is a lack of research into the safe use of assist poles in long term care, RHRA and private dwellings. Research into the use of assist poles is essential in determining overall safety profile of these devices. Health Canada should make recommendations for specific distances when installing transfer poles similar to recommendations for prevention of bed entrapment.
